## Defects / Snagging Report

# Lutterworth

SNAGGING INSPECTION

Thursday, 18 March 2021

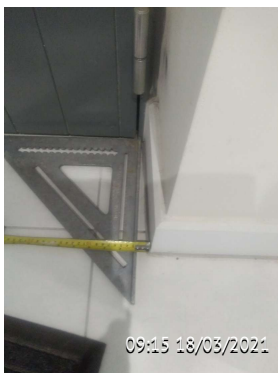
### Issue 1 front Door

Right hand door reveal out of square

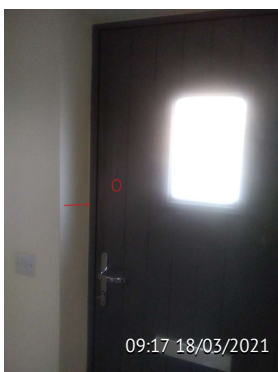
### Issue 2 Front Door

No spy hole fitted ad door chain

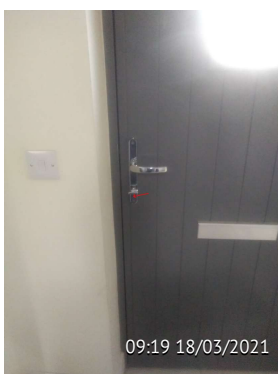
### Issue 3 Front Door

Lock loose

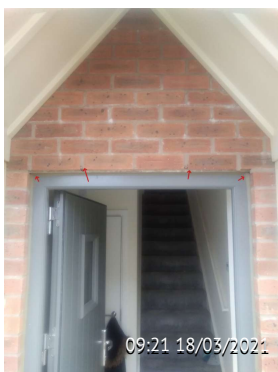
### Issue 4 Front Door

Lintel to point /weep vents clean out

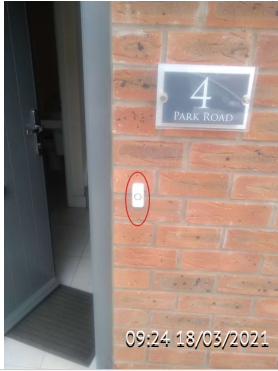
### Issue 5 Front Door

Assigned To Mulberry  
Door bell not level

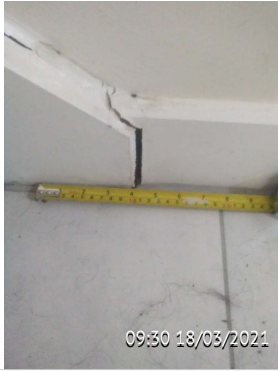
### Issue 9 Hall

Excessive shrinkage to skirting right hand side of stairs

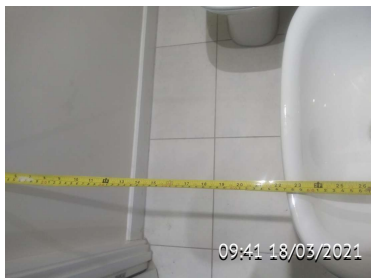
### Issue 12 Cloakroom

Room size does not comply with part m should be 650mm actual measurements are 560mm

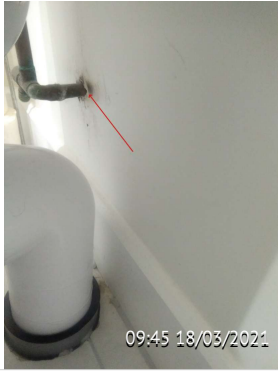
### Issue 13 Cloakroom

Burn marks to wall requires filling and decorations to rear of toilet

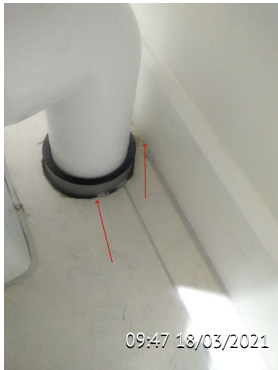
### Issue 14 Cloakroom

Grouting not complete to pipework to the rear of the toilet and mastic to complete

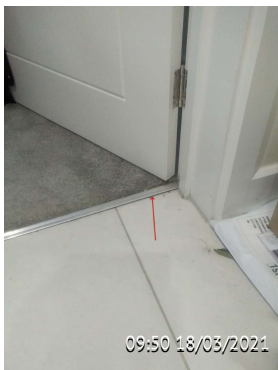
### Issue 16 Lounge

Adhesive showing to door bar

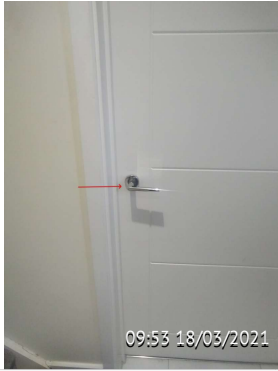
### Issue 17 Lounge

Door latch adjust as door rattles within opening

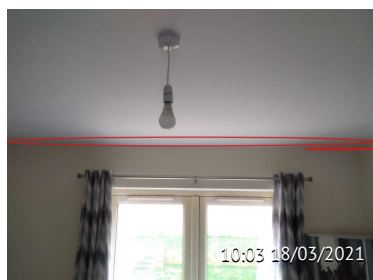
### Issue 22 Lounge

Assigned To Mulberry  
Excessive shrinkage to ceiling line above French door

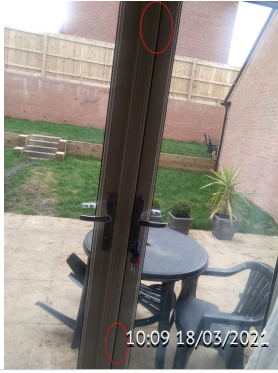
### Issue 25 Lounge

Assigned To Mulberry  
Seal to French door not sitting flat

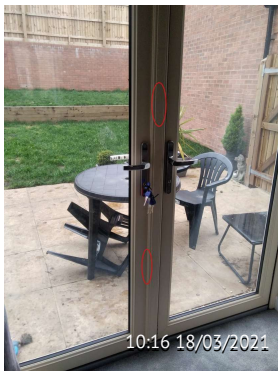
### Issue 28 Lounge

Assigned To Mulberry  
Damage to French doors

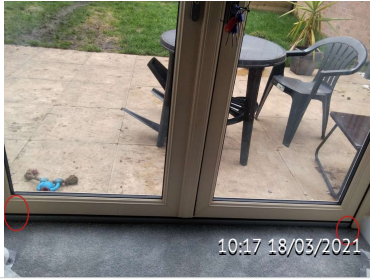
### Issue 29 Lounge

Expanding foam showing to bottom of French door frame

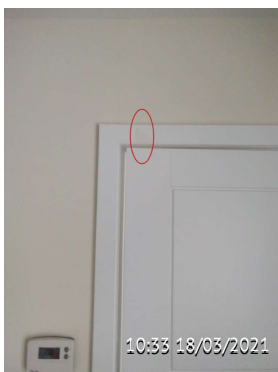
### Issue 32 Bedroom 1

Decorations to complete to arcs

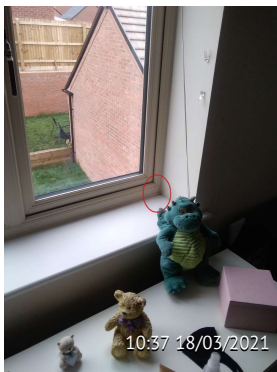
### Issue 35 Bedroom 1

Mastic to window frame to re apply

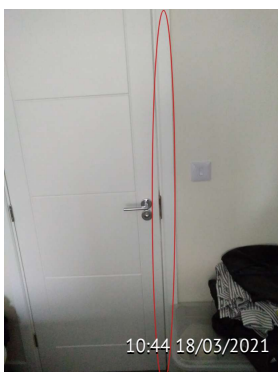
### Issue 38 Ensuite

Excessive gap to door to frame

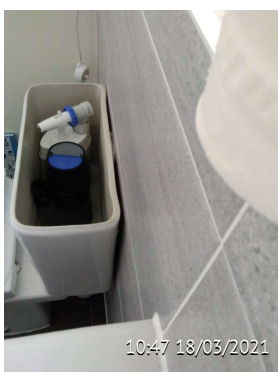
### Issue 39 Ensuite

Cistern not fitted tight to wall and not secure

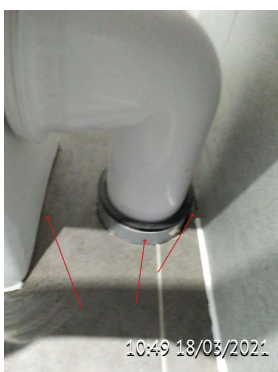
### Issue 40 Ensuite

Pipe not sealed around at floor and mastic not complete to rear of toilet

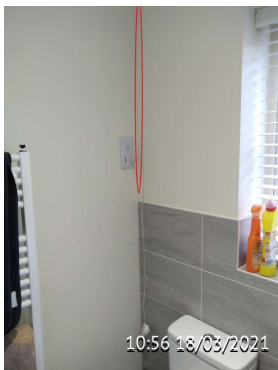
#### **Issue 44 Ensuite**

Excessive cracking to wall left hand side of window

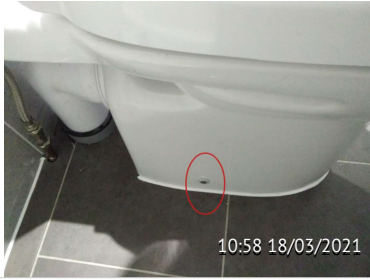
#### **Issue 45 Ensuite**

Screw cover missing from left side of toilet

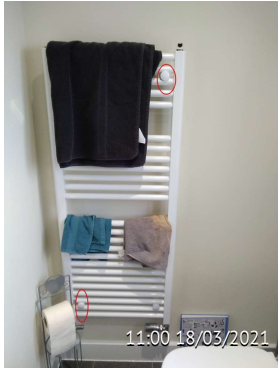
#### **Issue 46 Ensuite**

Brackets to towel rail secure

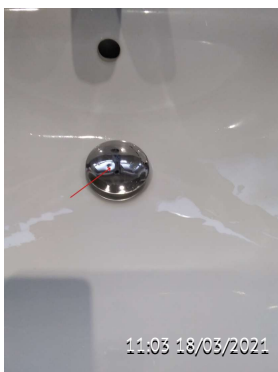
#### **Issue 48 Ensuite**

Dent to plug to wash basin

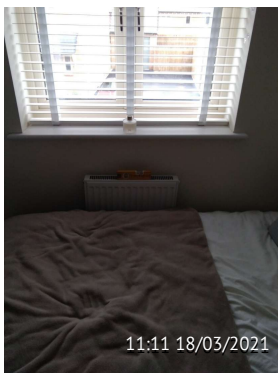
### Issue 53 Bedroom 2

Assigned To Mulberry  
Radiator not level

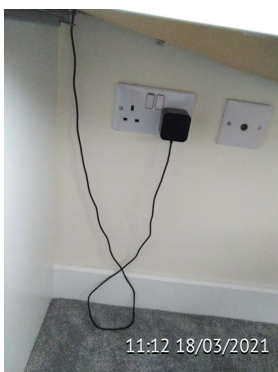
### Issue 54 Bedroom 2

Assigned To Mulberry  
Socket and TV point right hand side of door loose

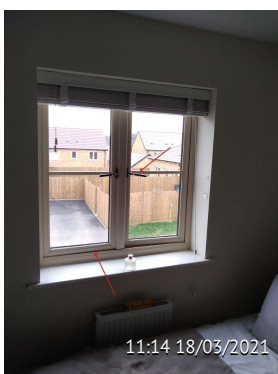
### Issue 55 Bedroom 2

Assigned To Mulberry  
Left hand window catching at the bottom and right hand window handle stiff

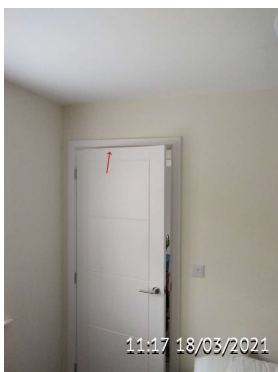
### Issue 56 Bedroom 3

Assigned To Mulberry  
Poor finish to door edge and door catching to top of frame

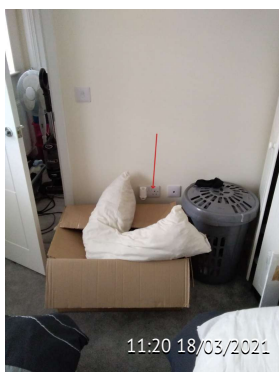
### Issue 58 Bedroom 3

Double socket right hand side door loose

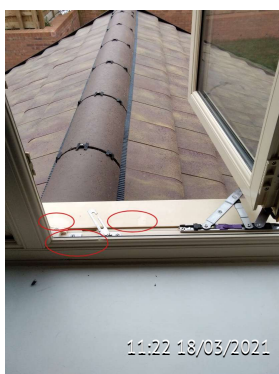
### Issue 59 Bedroom 3

Window frame damaged and external cill scratched

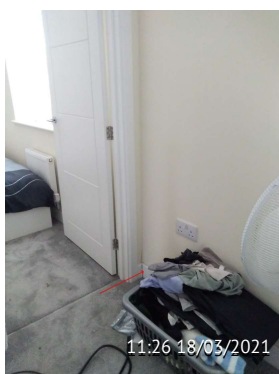
### Issue 60 Landing

Excessive shrinkage to right hand side of bedroom 3

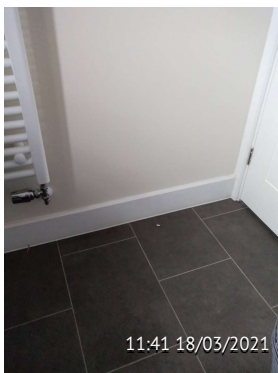
### Issue 69 Bathroom

Inconsistent paint finish to skirting behind door

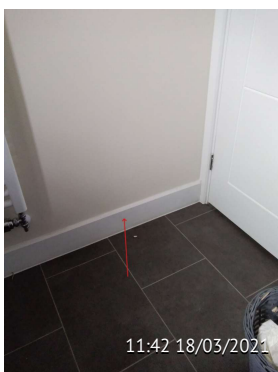
### Issue 70 Bathroom

Door stop not fitted to stop door clashing with wall

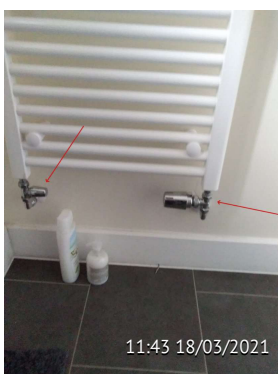
### Issue 71 Bathroom

Poor plaster finish to towel rail pipes

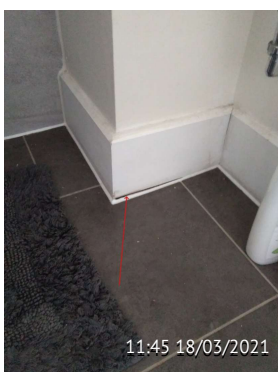
### Issue 72 Bathroom

Excessive gap below skirting right hand side of wash basin

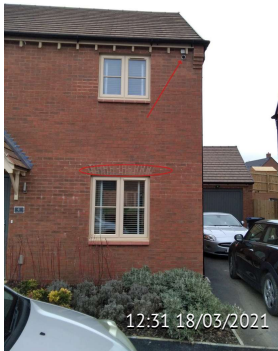
### Issue 82 Front

Poor pointing to brickwork above Lounge window and corble to point

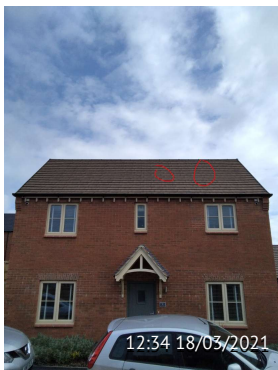
### Issue 84 Front

Roof tile broke

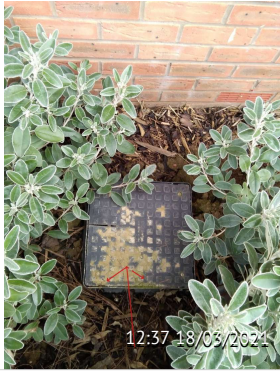
### Issue 85 Front

Damaged to manhole lid to kitchen and to secure

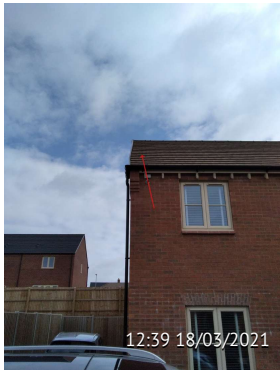
### Issue 86 Front

Dry verge not straight

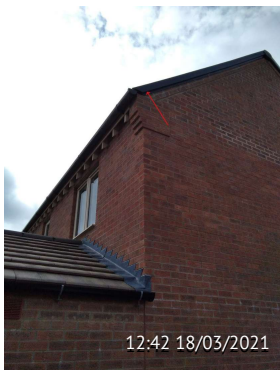
### Issue 88 Rear

Verge to roof no fixings

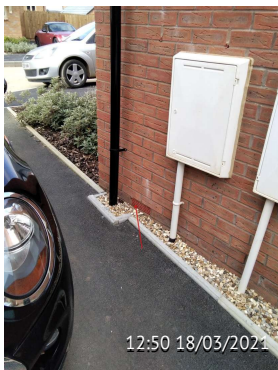
### **Issue 92 Front Right Hand Gable**

Air brick to point

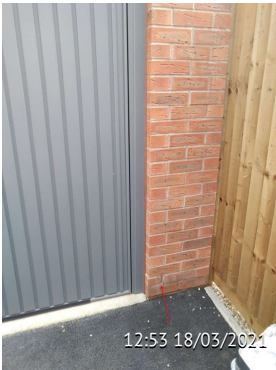
### Issue 94 Garage Front

Assigned To Mulberry  
Damage to brickwork right hand side of garage door

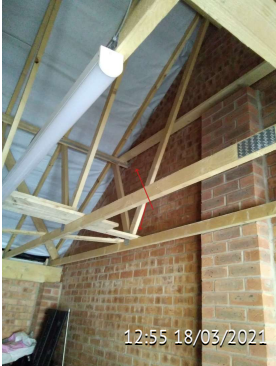
### Issue 95 Garage Internal

Assigned To Mulberry  
All lateral restraint straps should be double screwed to both gables

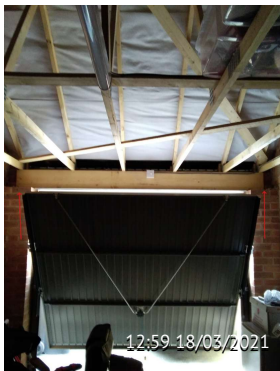
### Issue 97 Garage Internal Front

Pillars to clean and remove surplus mortar

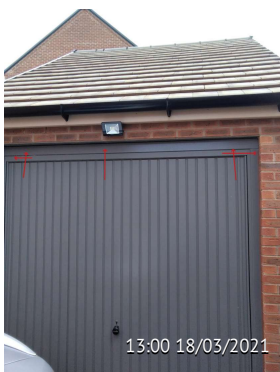
### Issue 98 Garage Front

Mastic to complete to frame

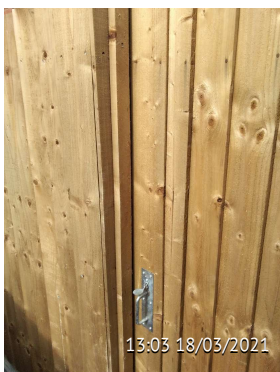
### Issue 99 Rear

Clapping strip to gate adjust

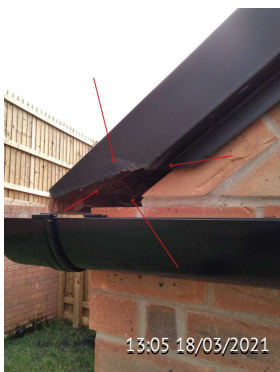
### Issue 101 Garage Rear

Poorly fitted verge to roof

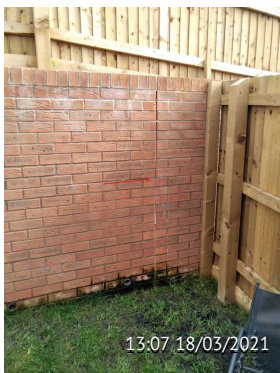
### **Issue 103 Rear**

Expansion joint not mastic to retaining wall

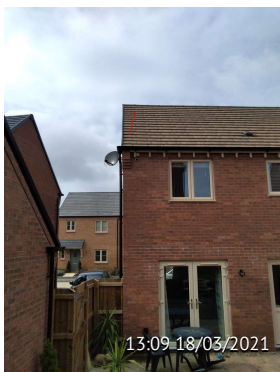
### **Issue 104 Rear**

Broken roof tile

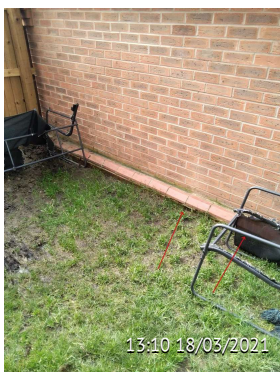
### **Issue 105 Rear Garage**

Plinth bricks to point

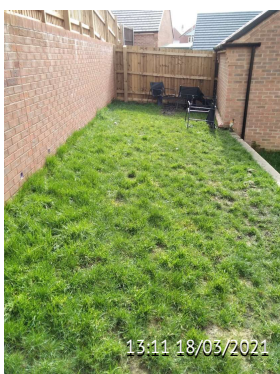
### **Issue 106 Rear**

Poor drainage to rear of garage

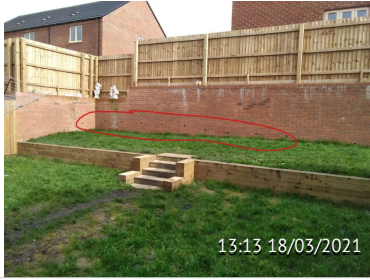
### Issue 107 Rear

Incorrect height of drainage to rear wall

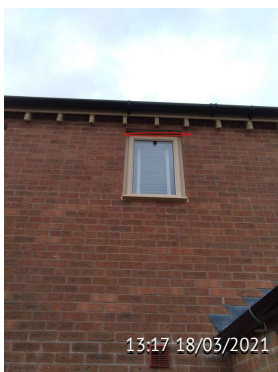
### Issue 110 Rear

Remove brick cut packers from lintel and make good

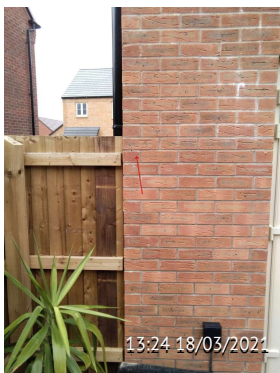
### Issue 115 Rear

Point hole left hand side of French lounge door

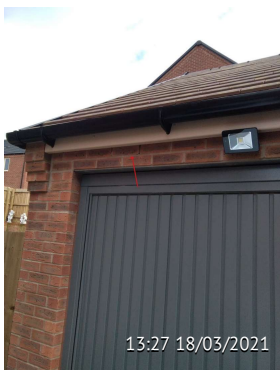
### Issue 116 Front Of Garage

Joint to point to brickwork

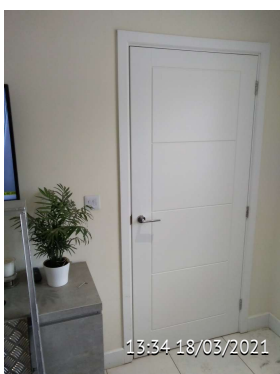
### Issue 117 Kitchen

Excessive gap to door to frame and not latching

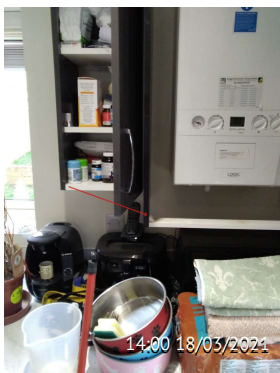
### Issue 127 Kitchen

Assigned To Mulberry  
No cod eye fitted to door

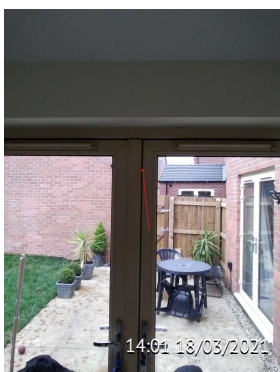
### Issue 128 Kitchen

Assigned To Mulberry  
French doors seal not sitting flat

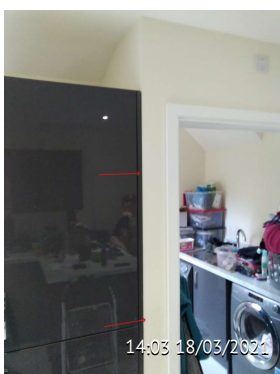
### Issue 129 Kitchen

Assigned To Mulberry  
Fridge /freezer housing to seal

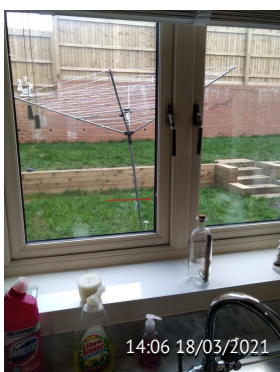
### Issue 130 Kitchen

Assigned To Mulberry  
Clean mastic from window

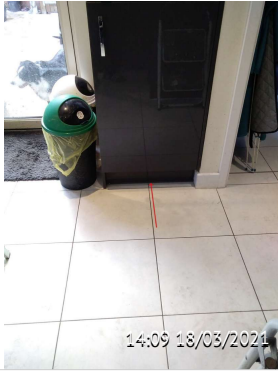
### Issue 131 Kitchen

Vent grill missing from bottom of fridge/ freezer

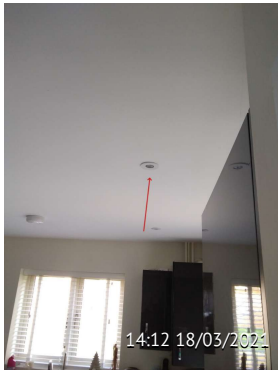
### Issue 132 Kitchen

Different colour shade of bulb

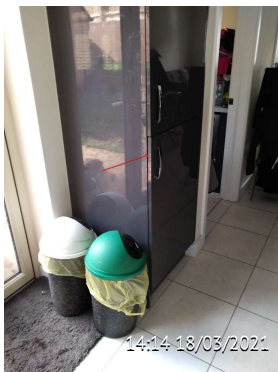
### Issue 133 Kitchen

Freezer door un even margins

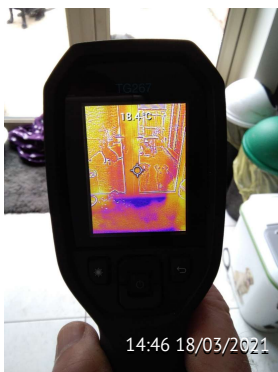
### Issue 147 Kitchen

Cold spot bottom French doors

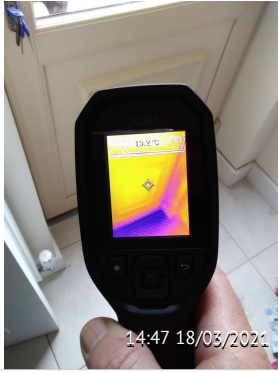
### Issue 148 Utility

Cold spot to bottom utility door
