## Defects / Snagging Report

# Lutterworth

SNAGGING INSPECTION

Thursday, 18 March 2021

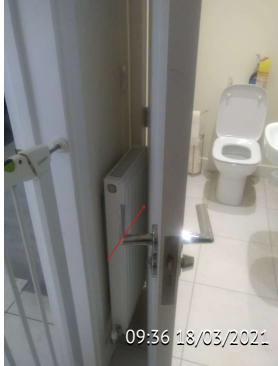
### Issue 10 Cloakroom

Excessive gap to door to frame and door latch adjust as door rattles within opening

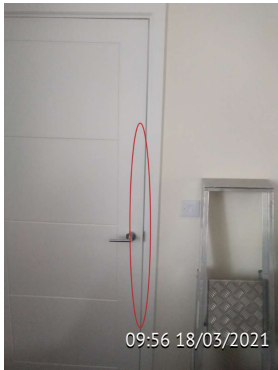
Door latch adjust as door rattles within opening

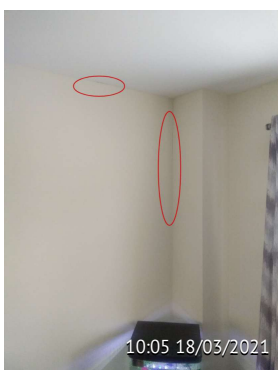
### Issue 22 Lounge

Assigned To Mulberry  
Excessive shrinkage to ceiling line above French door

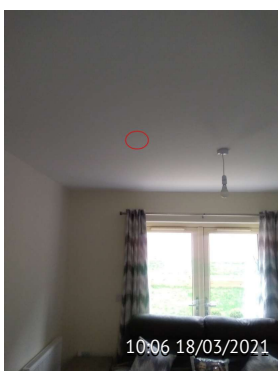
### Issue 23 Lounge

Assigned To Mulberry  
Excessive shrinkage to boxing and ceiling left hand side of front window

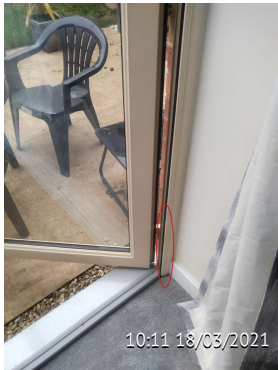
### Issue 25 Lounge

Assigned To Mulberry  
Seal to French door not sitting flat

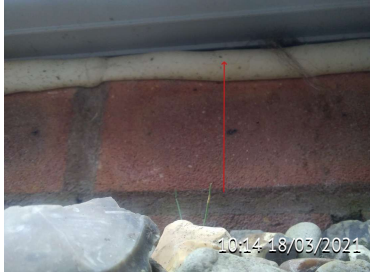
### Issue 26 Lounge

Assigned To Mulberry  
Right hand French door seal not sitting flat

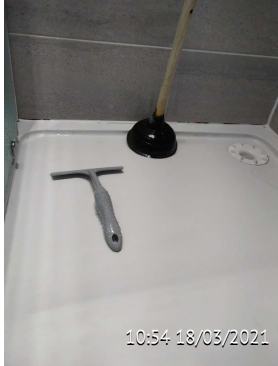
#### **Issue 42 Ensuite**

Shower water not draining

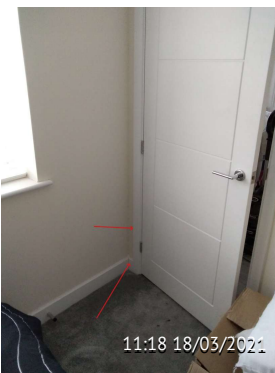
### Issue 56 Bedroom 3

Assigned To Mulberry  
Poor finish to door edge and door catching to top of frame

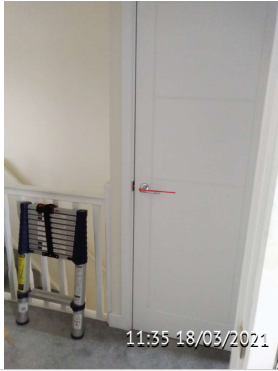
### Issue 64 Landing Store

Excessive gap to door to frame

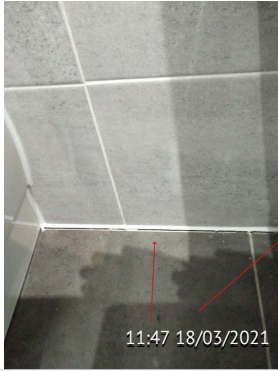
Excessive gap below skirting right hand side of wash basin

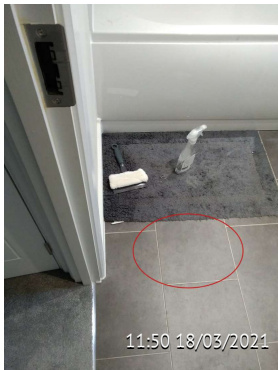
Pipes not hidden behind pedestal

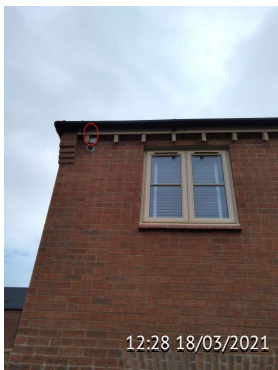
### Issue 79 Front

Detailed brickwork poor pointing and remove packer kitchen window

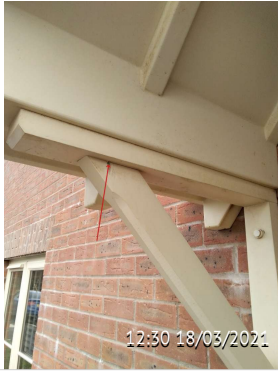
### Issue 80 Front

Remove nail from rafter and thin application to paint to rafters

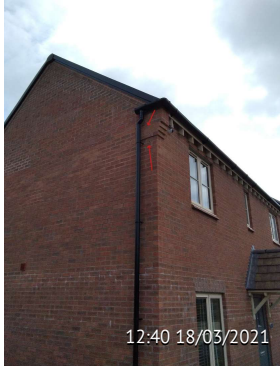
Dry verge not straight

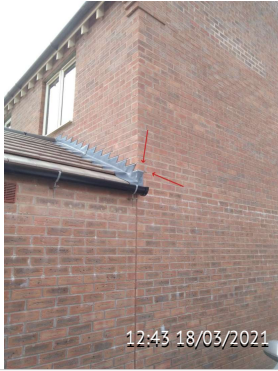
Verge to roof no fixings

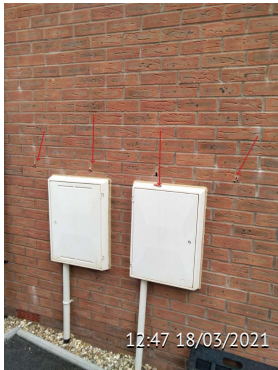
### **Issue 89 Rear**

No weep vents fitted to lead flashing and joint to point

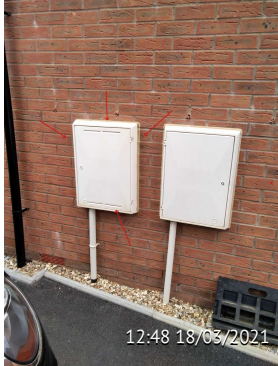
### **Issue 90 Front Right Hand Gable**

Weep vents cut and added and not built in

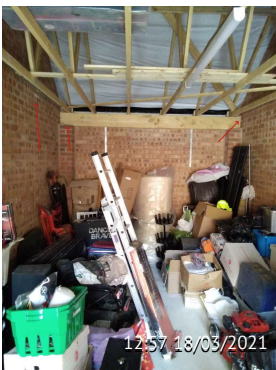
### Issue 95 Garage Internal

Assigned To Mulberry  
All lateral restraint straps should be double screwed to both gables

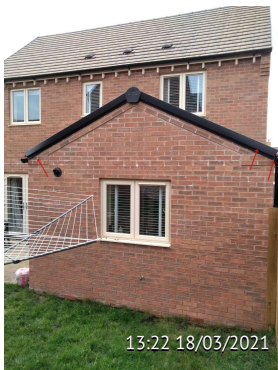
### Issue 112 Rear

Thin paint application to rafters

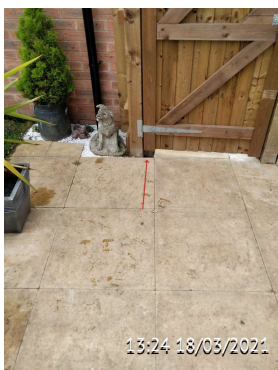
### Issue 113 Rear

Dry verge short plus not secure either end to kitchen

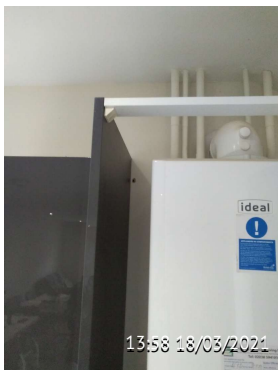
### Issue 125 Kitchen

Boiler flue sleeve fully fit and pipes to fully paint

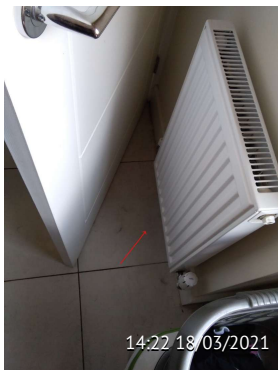
### Issue 136 Utility

Assigned To Mulberry  
Excessive gap to door to frame

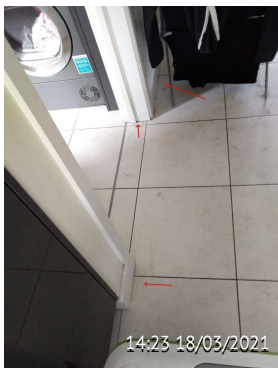
### Issue 137 Utility

Assigned To Mulberry  
Floor door stop to fit to stop door clashing with radiator

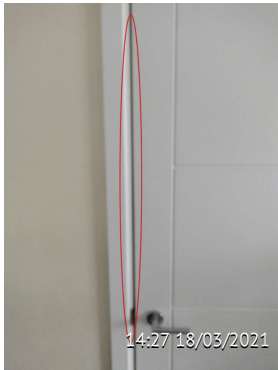
### Issue 139 utility

Skirting and wall to decorations to complete

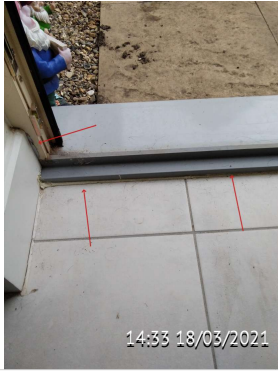
### Issue 143 Utility

Poor finish behind external door hinges
